**Flood Control Project Maintenance
Levee Inspections**
LMA District Cover Sheet
Spring 2017 Levee Inspection Results

Reclamation District No. 2101 Blewett

Spring 2017 Levee Inspection Results

Waterway			Bank	Unit Miles
Unit No. 01 San Joaquin River			Left	3.16
	Spring (March - May)	Summer (June - August)	(September - November) Fall	Winter (December - February)
Unit Maintenance Rating (Fall Only)				
Date of Inspection	3/28/2017 - 3/28/2017			
DWR Inspector	Maksim Khashchuk			
Accompanied By	Jim Coddington RD2101

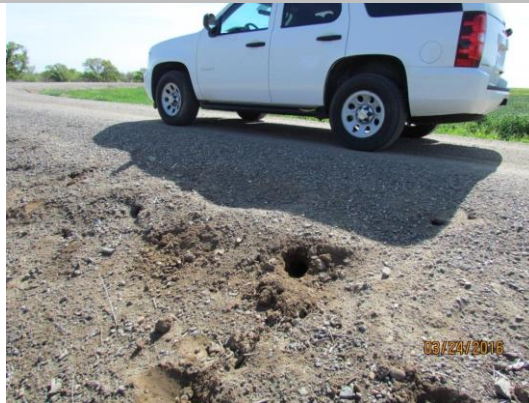
Photo 1 of 1 : SP_2017_RD2101_326_12_20170313_00008.jpg

View of the rodent holes on the waterside levee slope, facing upstream.

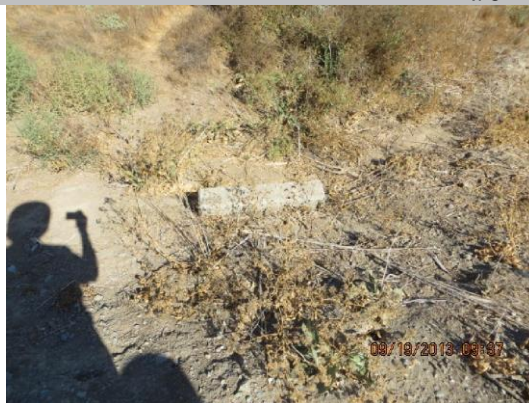
Photo 1 of 3 : UCIP_SP_2017_51391_47962.jpg

Comment Code					
Inspector Comment					
FS_ID:51391					
DS_ID:20699					
EP_NO: N/A					
Repair Type: Urgent					
Crossing Status: Found					
UCIP Comments: 11/16/2016 Same as previous inspection slide gate still missing. Also dense vegetation prevents access to crossing. Recommend removing vegetation along pipe alignment and both concrete headwalls to conduct proper inspection of structure. (O. Magana - DWR UCIP)09/17/2013 Slide gate missing from WS toe. Pipe has heavy sediment buildup. (W. Wylie - DWR UCIP)					
FIELD_STRUCT_DESC: 18-inch corrugated metal drainage pipe through levee, 3 feet below crown. Concrete headwalls are located on both the waterside (WS) and landside (LS) ends. Slide gate at headwall is located on the WS end. [Additional Reference(s): DWR Levee Log, 1992. USACE San Joaquin River O&M Manual Unit No. 12, December 1968, (HLM 0.05), Drawing No. 07-04-1666, sheets 1666/18 and 1666/52, station 00+70.]

Headwall on WS toe.

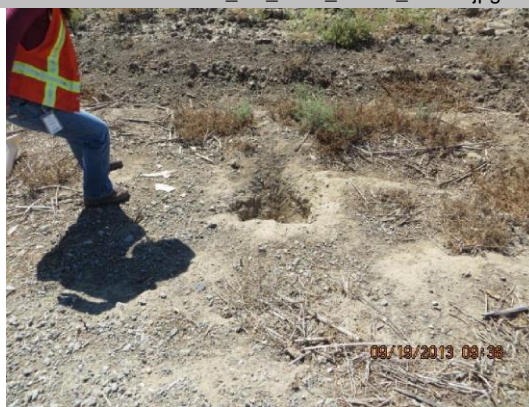
Photo 2 of 3 : UCIP_SP_2017_51391_47961.jpg

Pipe and headwall visible on LS toe.

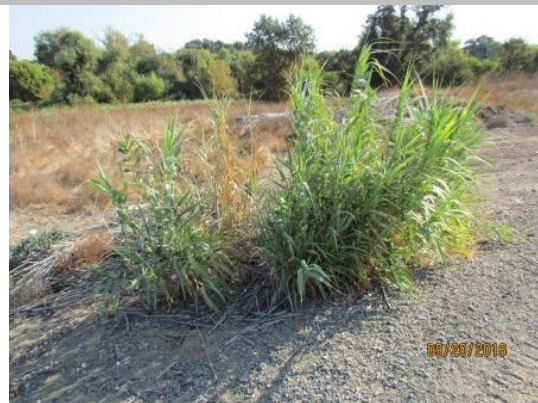
Photo 1 of 1 : SP_2017_RD2101_326_18_20170313_00010.jpg

LM Start	0.07	Rating **	M	Issue No.	18
LM End	0.07	Issue Type +	Ma	Location *	WS
Category	Earthen Levee			GPS Latitude/Longitude	
				Start	End
Item	Vegetation			37.657831 °	37.657831 °
				-121.253361 °	-121.253361 °
DWR ID	DWR_RD2101_01_f_2016_18				
Comment Code					
V2 : Remove the wild growth other than native grasses from the levee slopes.					
Inspector Comment					
Arundo on WS slope.

View of the arundo on the waterside levee slope.

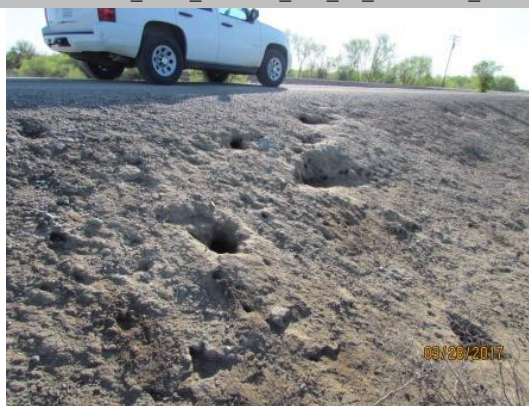
Photo 1 of 1 : SP_2017_RD2101_326_15_20170405_00041.jpg

View of the rodent burrows on the levee slope.

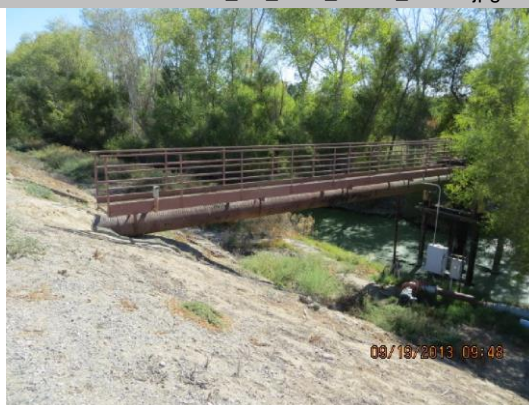
Photo 1 of 3 : UCIP_SP_2017_20752_34980.jpg

LM Start	0.20	Rating **	A/W	Issue No.	946
LM End	0.20	Issue Type +	Ma	Location *	LS
Category	Supplemental			GPS Latitude/Longitude	
				Start	End
Item	DWR UCIP LMA Responsibility			37.657130 °	37.657130 °
				-121.251695 °	-121.251695 °
DWR ID					
Comment Code					
Inspector Comment					
FS_ID:20752					
DS_ID:20700					
EP_NO: N/A					
Repair Type: No Action Needed					
Crossing Status: Found					
UCIP Comments:					
FIELD_STRUCT_DESC: 20-inch steel stormdrain pipe through levee					
2.0-feet below crown. Concrete "U" headwall and flap gate on the					
waterward end. Pump on pile structure on the landward side. Originally					
included in the 1968 O&M manual.					
FS Date: 9/19/2013

Pump on platform at LS.

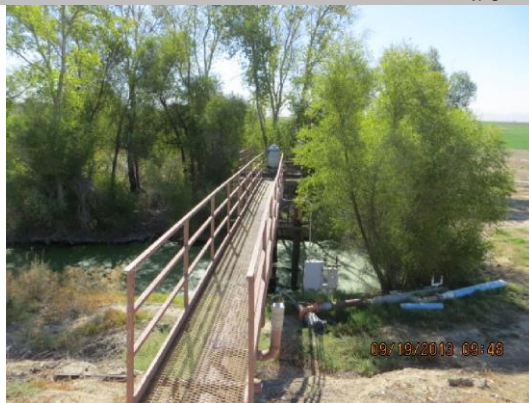
Photo 2 of 3 : UCIP_SP_2017_20752_34979.jpg

Pump on platform at LS.

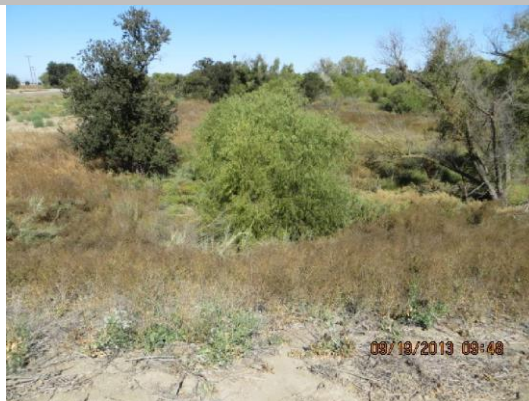
Photo 3 of 3 : UCIP_SP_2017_20752_34978.jpg

Concrete U-shaped headwall on LS toe at willow tree on WS toe.

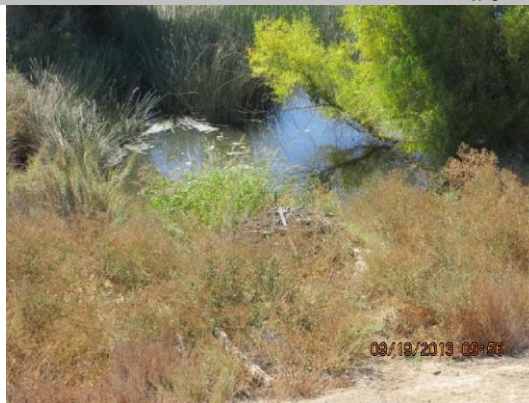
Photo 1 of 3 : UCIP_SP_2017_20785_35046.jpg

LM Start:	0.31	Rating **	M	Issue No.	947
LM End	0.31	Issue Type +	Ma	Location *	LS
Category	Supplemental			GPS Latitude/Longitude	
				Start	End
Item	DWR UCIP LMA Responsibility			37.658142 °	37.658142 °
				-121.250047 °	-121.250047 °
DWR ID					
Comment Code					
Inspector Comment					
FS_ID:20785					
DS_ID:20701					
EP_NO: N/A					
Repair Type: Non-Urgent					
Crossing Status: Found					
UCIP Comments: Inlet blocked by soil from beaver activity. Outlet covered in soil.					
FIELD_STRUCT_DESC: 24-inch corrugated metal pipe through levee 21.0 feet below crown. Headwall and slide gate on the landward end. Concrete "U" headwall and flap gate on the waterward end. Originally included in the 1968 O&M manual.					
FS Date: 9/19/2013

Slide gate at concrete headwall on LS toe.

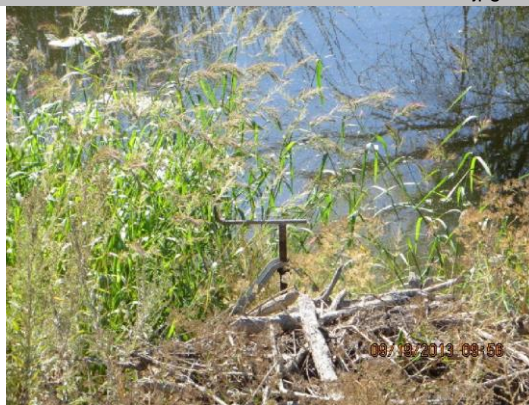
Photo 2 of 3 : UCIP_SP_2017_20785_35045.jpg

Slide gate at concrete headwall on LS toe.

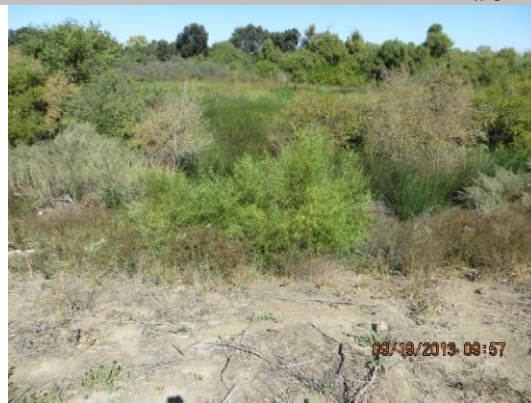
Photo 3 of 3 : UCIP_SP_2017_20785_35044.jpg

Outlet covered in soil but likely at willow tree on WS slope.

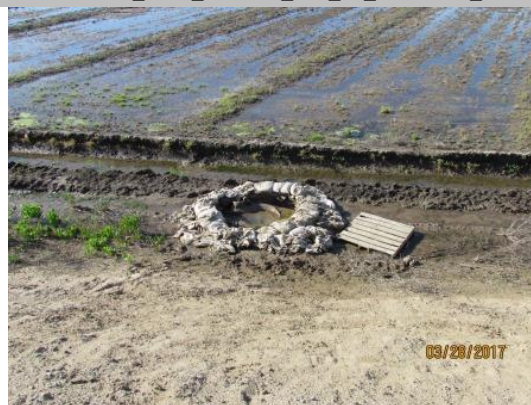
Photo 1 of 1 : SP_2017_RD2101_326_16_20170405_00042.jpg

LM Start	0.69	Rating **	U	Issue No.	16
LM End	0.69	Issue Type +	Ob	Location *	LS
Category	Earthen Levee			GPS Latitude/Longitude	
				Start	End
Item	Seepage / Sandboils			37.659922 °	37.659922 °
				-121.244415 °	-121.244415 °
DWR ID	DWR_RD2101_01_s_2017_16				
Comment Code					
Inspector Comment					
Boil still flowing and carrying some material.

View of the boil and seepage area at the levee toe.

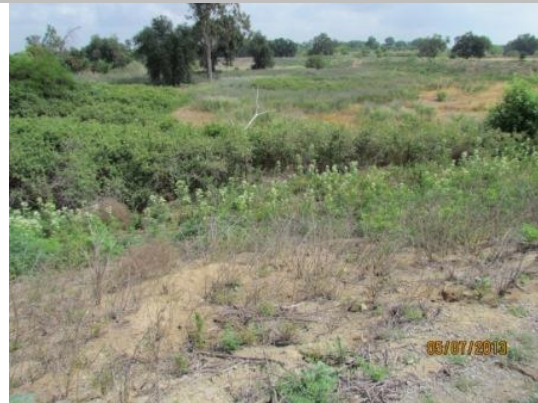
Photo 1 of 1 : SP_2017_RD2101_326_26_20170313_00012.jpg

View of the rodent burrows on the waterside levee slope.

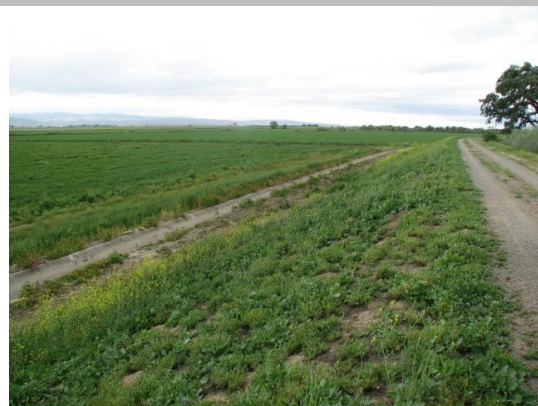
Photo 1 of 1 : SP_2017_RD2101_326_944_20170313_00020.jpg

LM Start	0.73	Rating **	M	Issue No.	944
LM End	1.76	Issue Type +	En	Location *	LS
Category	Earthen Levee			GPS Latitude/Longitude	
				Start	End
Item	Encroachments			37.659827 °	37.651049 °
				-121.243675 °	-121.231475 °
DWR ID	DWR_RD2101_01_s_2012_944				
Comment Code					
DT : Ditch					
Inspector Comment

Concrete ditch near landside toe.

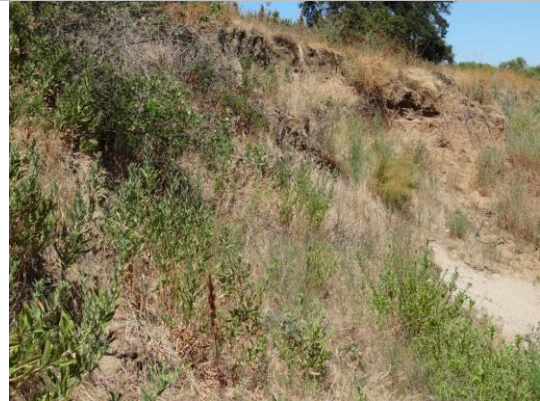
Photo 3 of 3 : SP_2017_RD2101_326_1_20170313_00003.jpg

Comment Code						
Inspector Comment						
07/12/2016: No significant change observed.						
08/19/2015: No significant change observed.						
07/17/2014: No significant change observed.						
09/20/2013: Site has been visited. There are signs of further erosion development along the levee slope and toe.						
07/18/2012: The erosion has further developed toward levee crown. Vegetation has been removed.						
08/18/2011: The erosion progressed significantly during the past flood season. The levee toe along the erosion site was washed away, and the erosion has cut the levee structure up to the point about 1/3 of the levee slope. The scarp height is approximately 17 feet. Very dense vegetation and trees are visible.						
10/19/2010: No significant change observed on site. Remaining levee berm topsoil is of silty sand mixture. The erosion is near the downstream transition. An eddy has formed, and has scoured away a 100-foot section of the bank, possibly encroaching into the levee prism. Vegetation on site includes willows, oak, and cotton wood located from the bench to the toe. On the landside are rows of corn crop.

08/05/2010: Recommended for Repair, per CLRO.						
2009: Site recommended as annual assessment and monitoring if critical erosion site, per CLRO CES Evaluation 2008 Report; an eddy has formed, eroding bank and intruding into the levee prism; Site # is the same as RM76.3, LM1.89; previously rated "U".						
08/30/2007: Recommended for short list of immediate repair sites; silty sand levee material. [2016 Site ID:RD2101U01RM73.92]

Close view of the erosion. Levee crest is approximately 8 feet above the erosion.

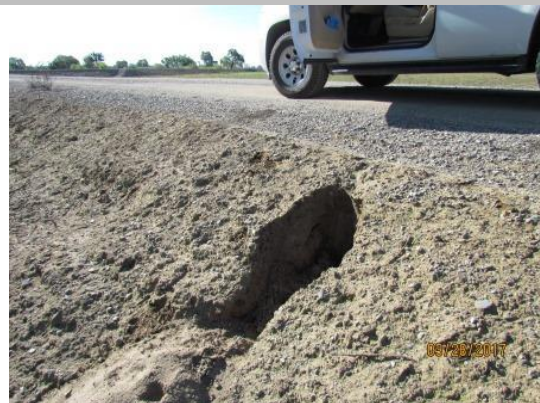
Photo 1 of 1 : SP_2017_RD2101_326_24_20170405_00043.jpg

LM Start	2.23	Rating **	U	Issue No.	24
LM End	2.23	Issue Type +	Ma	Location *	LS
Category	Earthen Levee			GPS Latitude/Longitude	
				Start	End
Item	Animal Control			37.647088 °	37.647088 °
				-121.225077 °	-121.225077 °
DWR ID	DWR_RD2101_01_s _ 2017_24				
Comment Code					
A1 : Exterminate rodents and backfill and compact or grout burrows.					
Inspector Comment					
Backfill and compact rodent holes.

View of the rodent burrow on the levee slope.

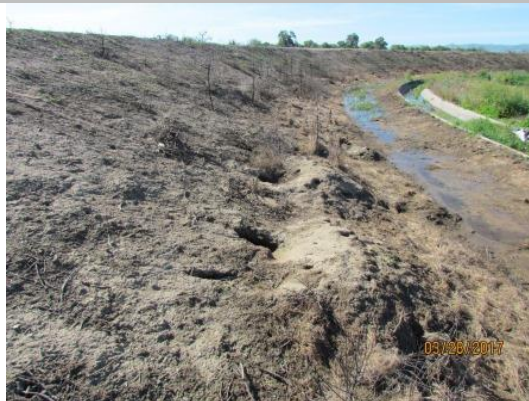
Photo 1 of 1 : SP_2017_RD2101_326_25_20170405_00044.jpg

View of the multiple rodent burrows on the levee slope.

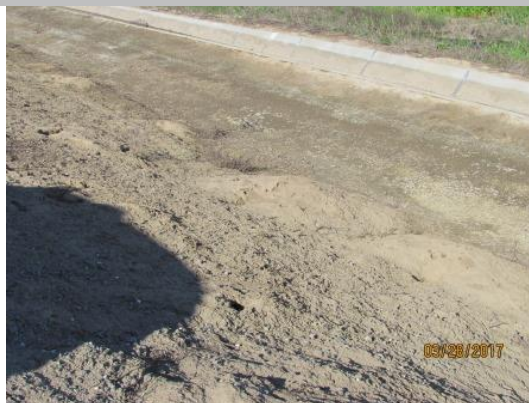
Photo 1 of 1 : SP_2017_RD2101_326_30_20170405_00047.jpg

LM Start	2.52	Rating **	U	Issue No.	30
LM End	2.52	Issue Type +	Ma	Location *	LS
Category	Earthen Levee			GPS Latitude/Longitude	
				Start	End
Item	Animal Control			37.644166 °	37.644166 °
				-121.228386 °	-121.228386 °
DWR ID	DWR_RD2101_01_s_2017_30				
Comment Code					
A1 : Exterminate rodents and backfill and compact or grout burrows.					
Inspector Comment					
Multiple large rodent holes.

View of the rodent burrows on the levee slope near the toe.

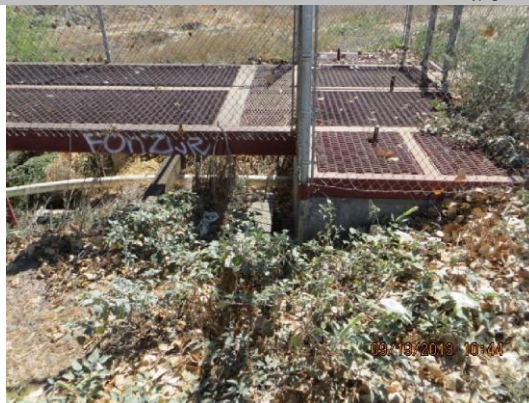
Photo 2 of 3 : UCIP_SP_2017_20865_35109.jpg

Gate valve in concrete vault on WS shoulder.

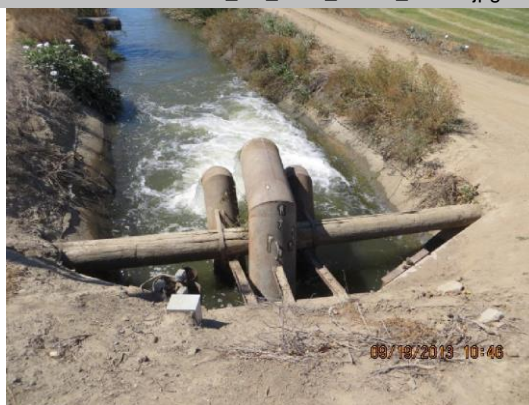
Photo 3 of 3 : UCIP_SP_2017_20865_35108.jpg

20-inch steel pipe discharges into concrete channel on LS.

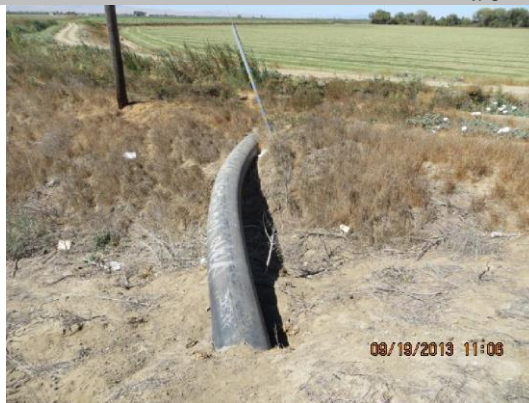
Photo 1 of 2 : UCIP_SP_2017_22915_39043.jpg

LM Start	2.72	Rating **	M	Issue No.	949
LM End	2.72	Issue Type +	En	Location *	LS
Category	Supplemental			GPS Latitude/Longitude	
				Start	End
Item	DWR UCIP Field Study			37.641798 °	37.641798 °
				-121.229714 °	-121.229714 °
DWR ID					
Comment Code					
Inspector Comment					
FS_ID:22915 DS_ID:24679 EP_NO: N/A Repair Type: Non-Urgent Crossing Status: Found UCIP Comments: 09/26/2016 - (T. Hatch/UCIP) Inspector indicated that pipe had been removed for several years. Need additional information to determine if the pipe was removed properly and the levee recompacted to specifications. 09/19/2013 - (W. Wylie/UCIP) No permit identified for this crossing. FIELD_STRUCT_DESC: *REMOVED* 18-inch PVC irrigation pipe through the levee 3.5-feet below the crown. No pump or other appurtenances visible. FS Date: 9/19/2013

18-inch PVC pipe visible at LS slope.

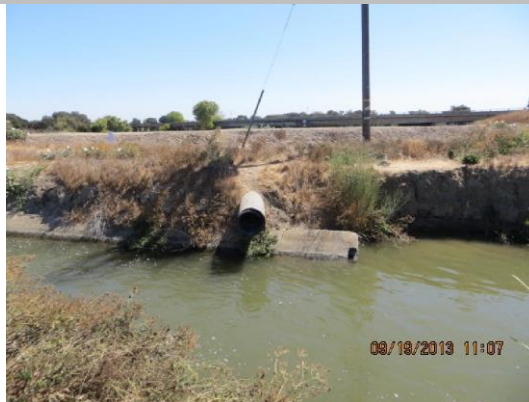
Photo 2 of 2 : UCIP_SP_2017_22915_39042.jpg

18-inch PVC pipe visible at outlet to irrigation canal on LS slope.

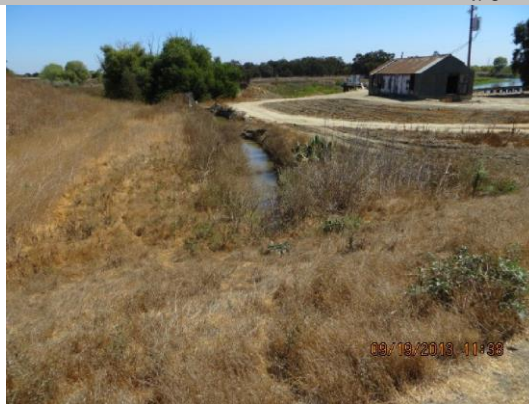
Photo 2 of 3 : UCIP_SP_2017_51392_35141.jpg

Concrete headwall visible on WS toe at canal.

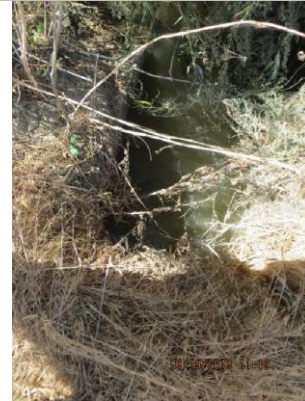
Photo 3 of 3 : UCIP_SP_2017_51392_35140.jpg

Concrete headwall at LS toe.

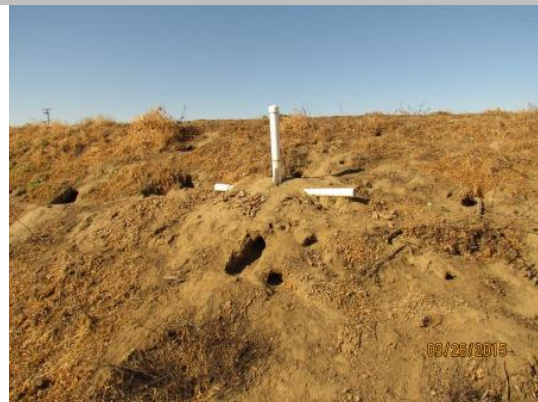
Photo 1 of 1 : SP_2017_RD2101_326_27_20170313_00013.jpg

LM Start	2.83	Rating **	U	Issue No.	27
LM End	2.83	Issue Type +	Ma	Location *	WS
Category	Earthen Levee			GPS Latitude/Longitude	
				Start	End
Item	Animal Control			37.640425 °	37.640425 °
				-121.230139 °	-121.230139 °
DWR ID	DWR_RD2101_01_s_2012_27				
Comment Code					
A3 : No rodents visible, but rodent burrows visible; need to backfill and compact or grout burrows.					
Inspector Comment					
Burrows on both sides of levee. Backfill the burrows to restore the levee to original condition.

View of multiple rodent holes on the levee slope.

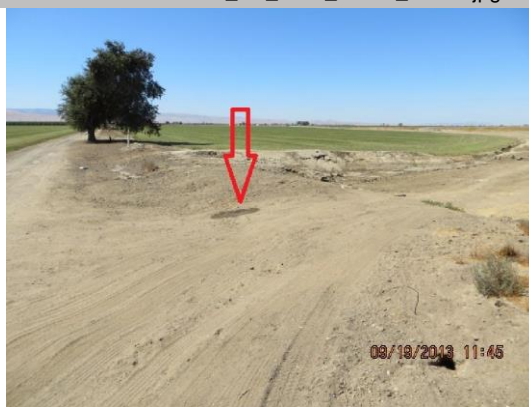
Photo 2 of 3 : UCIP_SP_2017_20873_35145.jpg

Leak in pipe off LS toe.

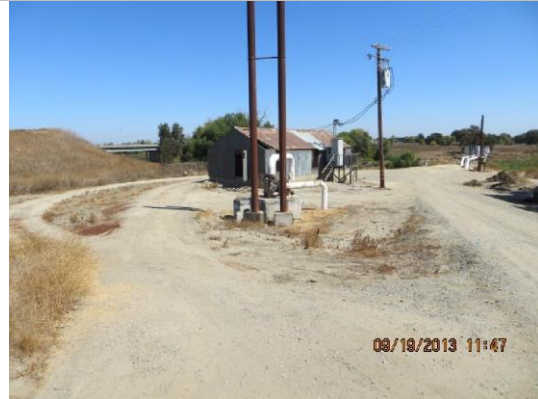
Photo 3 of 3 : UCIP_SP_2017_20873_35144.jpg

12-inch steel riser at concrete box with gatevalve on WS berm.

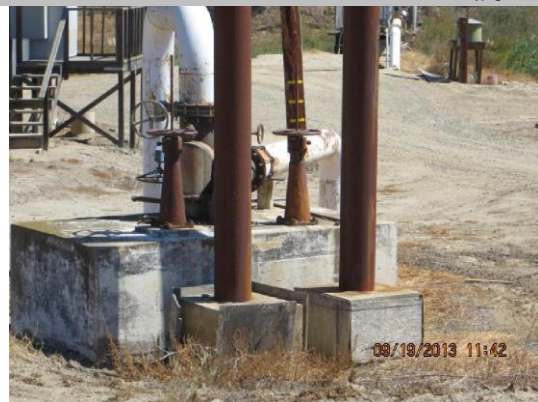
Photo 1 of 3 : UCIP_SP_2017_20874_35151.jpg

LM Start	2.85	Rating **	M	Issue No.	952
LM End	2.85	Issue Type +	En	Location *	WS
Category	Supplemental			GPS Latitude/Longitude	
				Start	End
Item	DWR UCIP Field Study			37.640185 °	37.640185 °
				-121.230067 °	-121.230067 °
DWR ID					
Comment Code					
Inspector Comment					
FS_ID:20874 DS_ID:20712 EP_NO: N/A Repair Type: Non-Urgent Crossing Status: Found UCIP Comments: Leak off LS toe may indicate internal failure. Good candidate for video inspection. FIELD_STRUCT_DESC: 2 of 2: 30-inch concrete pipe through levee 11.0 feet below crown. Pump on metal pier on waterside berm. 12-inch steel riser next to 6'X10.5' concrete box with Screw gate inside on waterward side. Abandoned Pump house on waterward side. Originally included in the 1968 O&M manual. FS Date: 9/19/2013

Gatevalve in concrete vault with standpipe off WS toe.

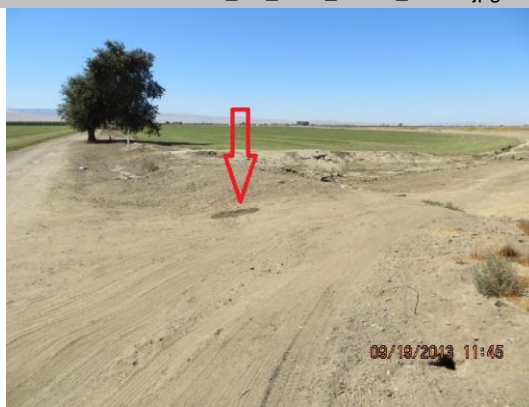
Photo 3 of 3 : UCIP_SP_2017_20874_35149.jpg

Leak in pipe off LS toe.

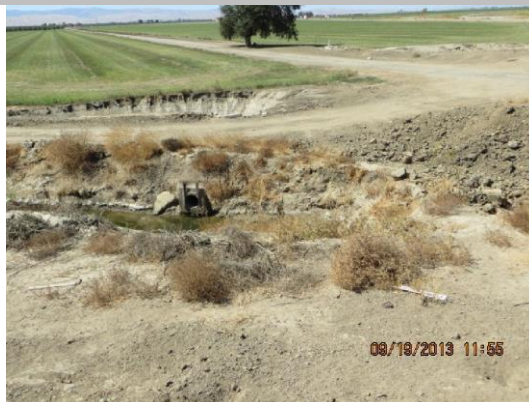
Photo 2 of 3 : UCIP_SP_2017_20875_35155.jpg

Inlet on LS toe with concrete headwall.

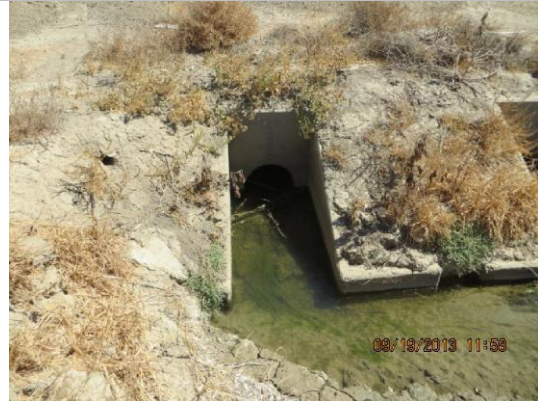
Photo 3 of 3 : UCIP_SP_2017_20875_35154.jpg

Inlet on LS toe with concrete headwall.

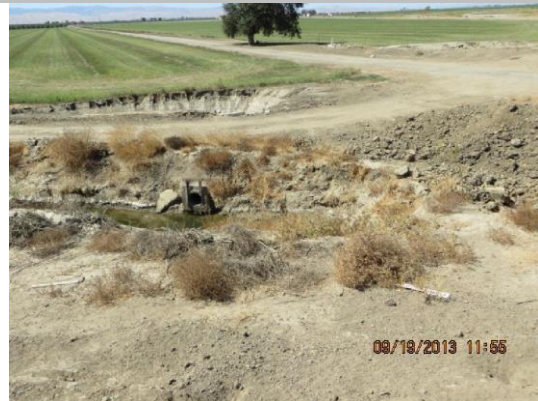
Photo 1 of 3 : UCIP_SP_2017_20876_35159.jpg

Concrete inlet on LS toe at canal.

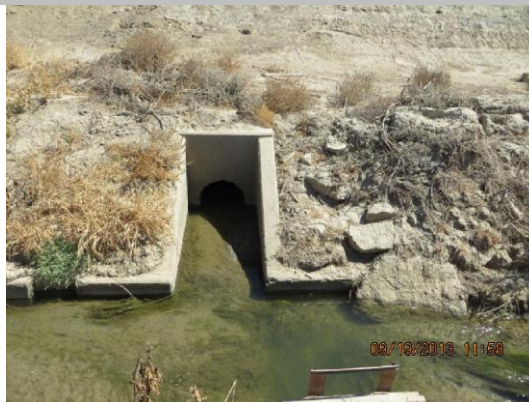
Photo 3 of 3 : UCIP_SP_2017_20876_35157.jpg

Concrete inlet on LS toe at canal.

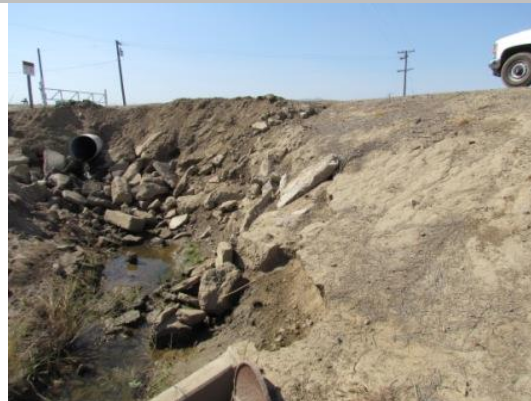
Photo 1 of 2 : SP_2017_RD2101_326_29_20170313_00015.jpg

View of repaired site, but it appears that erosion is still occurring.
09/25/2012

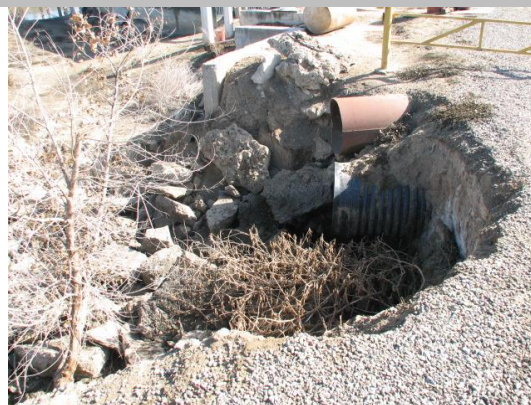
Photo 2 of 2 : SP_2017_RD2101_326_29_20170313_00016.jpg

Levee slope is being eroded at this location. Repair needed to preserve access road.

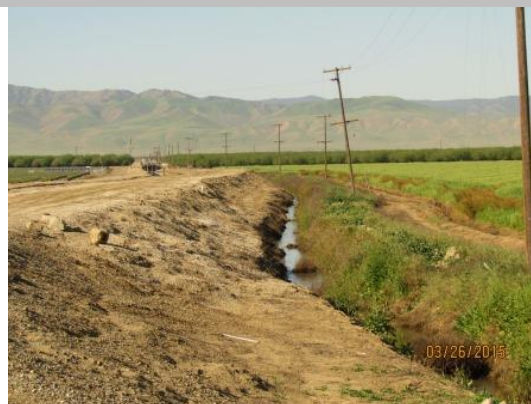
Photo 1 of 1 : SP_2017_RD2101_326_8_20170313_00007.jpg

View of the ditch at the landside levee toe.

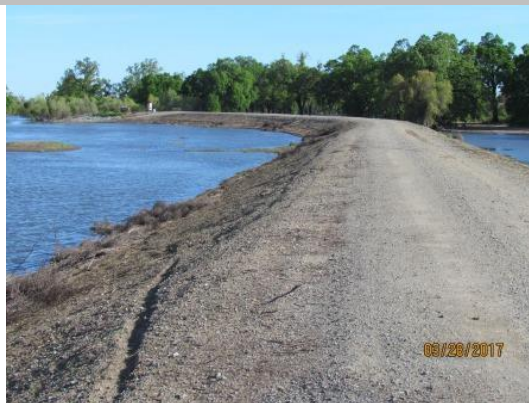
Photo 1 of 1 : SP_2017_RD2101_327_1_20170405_00001.jpg

View of the acceptable vegetation on the levee slope.
